Remote diagnosis of a pure *Half X* vibration problem in a power plant

by **Bryan Finch**

Bently Nevada United Kingdom

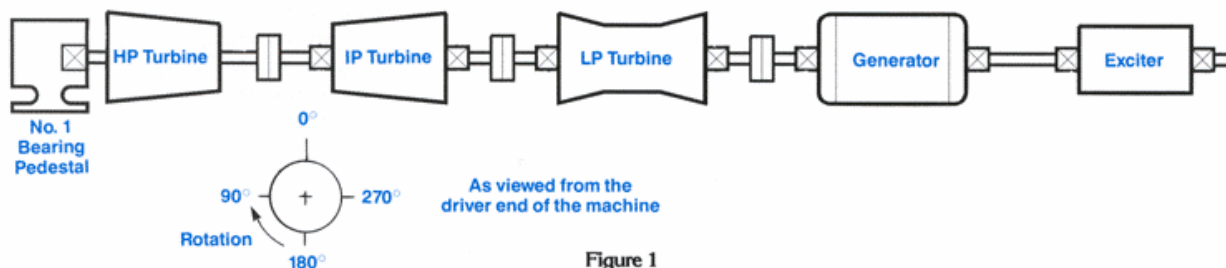
Figure 1
Machine train diagram

This article discusses a problem which occurred on one of the 200 MW turbines. The machine train diagram (Figure 1) shows the general layout. All the shafts are solidly coupled.
